PRELIMINARY NONDESTRUCTIVE EVALUATION MANUAL FOR THE SPACE SHUTTLE

**PRELIMINARY NONDESTRUCTIVE EVALUATION MANUAL
FOR THE SPACE SHUTTLE**

APPENDIX TO FINAL REPORT

**LOCKHEED-GEORGIA COMPANY
A DIVISION OF LOCKHEED AIRCRAFT CORPORATION
MARIETTA, GEORGIA 30063**

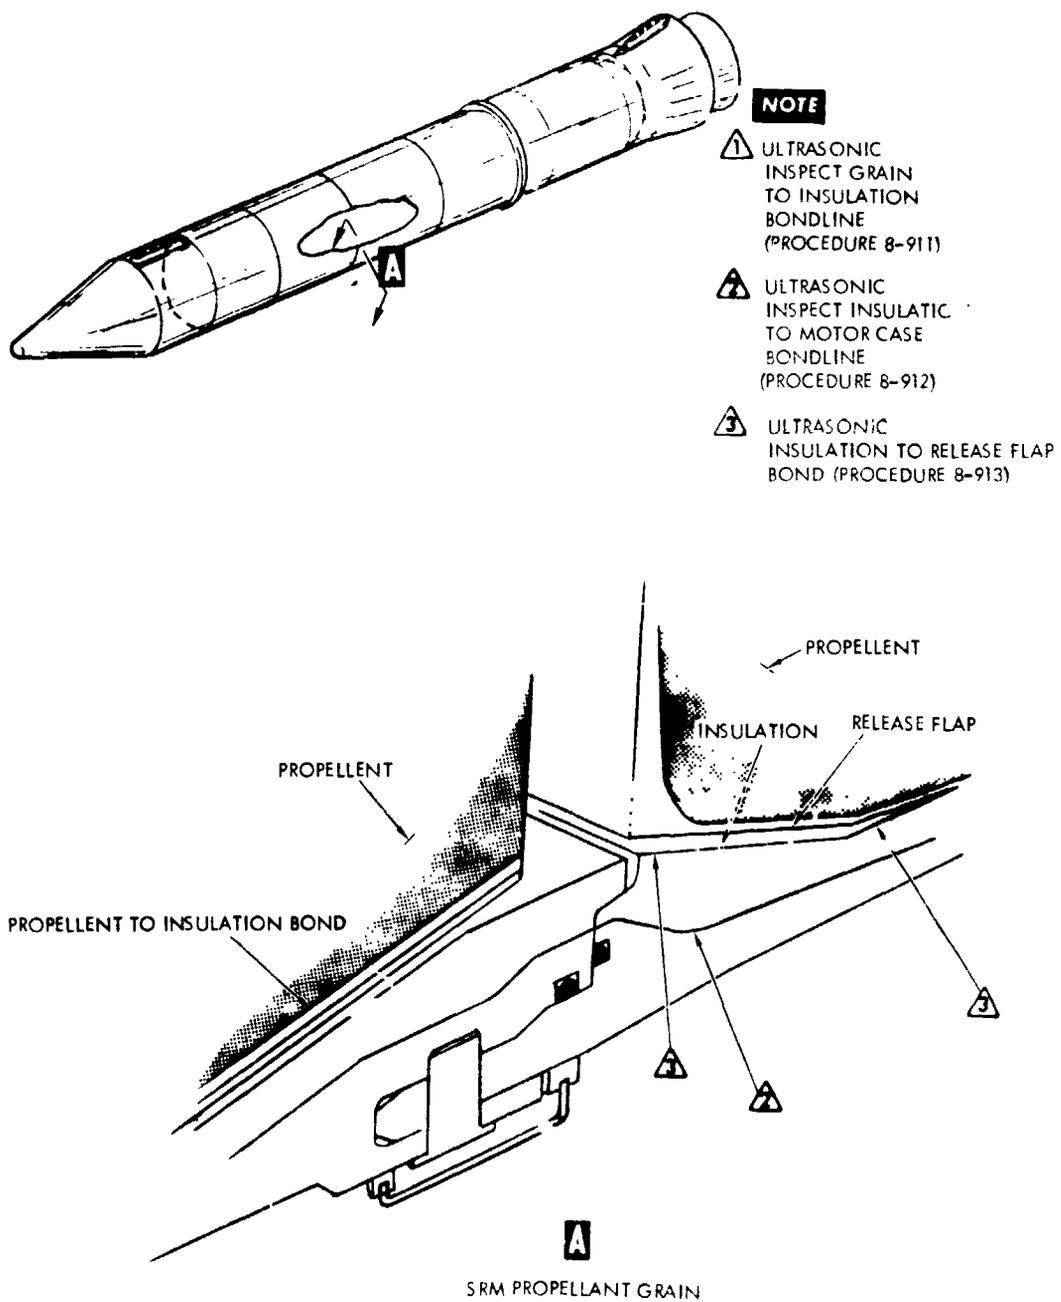
Figure 8-9. Propellant Grain and Case Interfaces (Sheet 1 of 2)

ACCESS: The release flaps on each SRM segment are accessible to visual inspection prior to pre-launch assembly.

NDT TECHNIQUES: Recommended NDT technique is contact pulse-echo ultrasonics (Para. 1.5.5.6) on that portion of the aft or forward grain that is covered by a release flap or inhibitor. No pre-launch inspection is recommended of the cylindrical section of the release flap to insulation bond because this bond line is under a very low stress load. If no defects are noted on the DDT&E motors, this inspection can be deleted and used only for motors which are exposed to unusual transportation environments.

PROCEDURE NO: 8-913, FIGURE 8-9
MAJOR ASSEMBLY: SRB, PROPELLANT GRAIN
ZONE 9
SUBASSEMBLY: INSULATION TO RELEASE
FLAP BOND

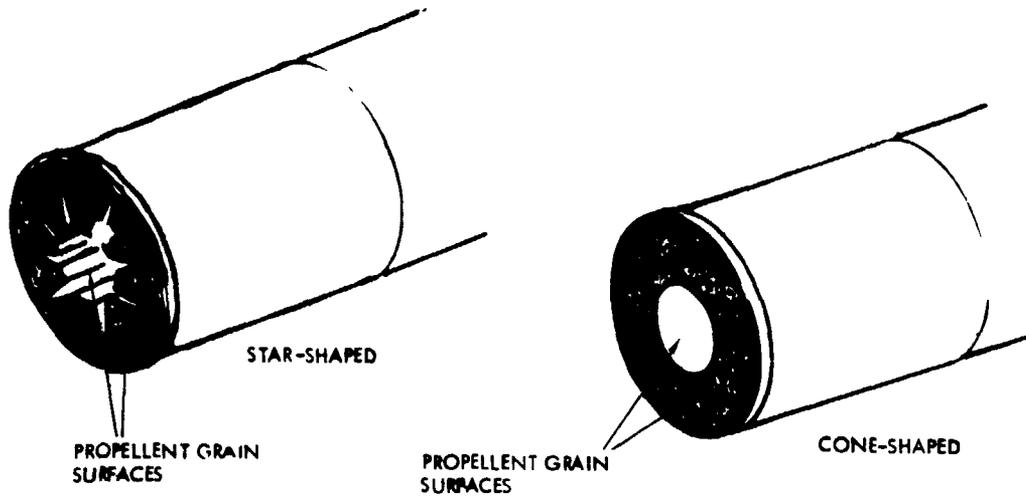
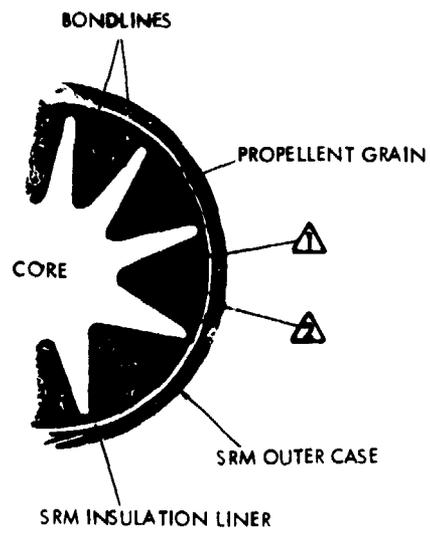
Figure 8-9. Propellant Grain and Case Interfaces (Sheet 2 of 2)

OPTICAL
INSPECT PROPELLENT
GRAIN SURFACES
(PROCEDURE 8-910)

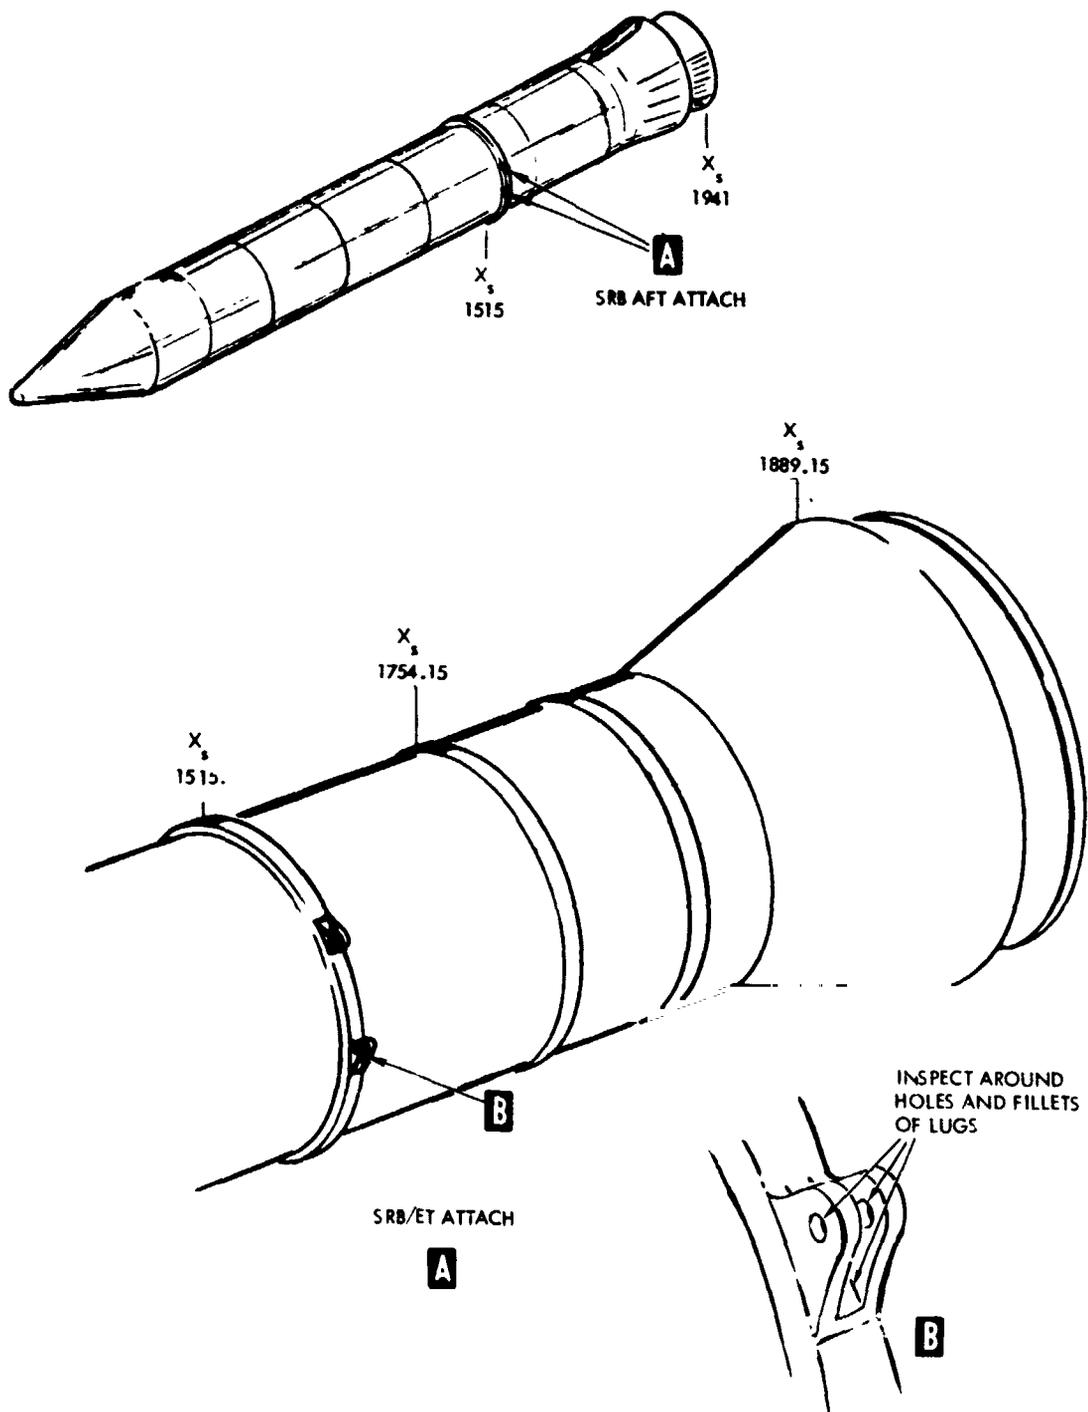
Figure 3-10. ET/SRB Aft Attach Fittings and Trusses

ACCESS: The exterior portion of the fitting has ready access in the unmated condition and should be inspected after recovering terminating each SRB mission.

NDT TECHNIQUES: Primary: Ultrasonic shear wave (Para. 1.5.5.3 B) and fluorescent penetrant (Para. 1.5.2.1, Fig. 1-9).
 Backup: Penetrant or eddy current bolt holes for the clevis bolt holes.

PROCEDURE NO: 8-914, FIGURE 8-10
MAJOR ASSEMBLY: SOLID ROCKET BOOSTER
 ZONE 9
SUBASSEMBLY: AFT ATTACHMENT STATION
DRAWING(S): VL72-000103A
COMPONENT/AREA DESCRIPTION: ET/SRB AFT ATTACH FITTINGS AND TRUSSES.

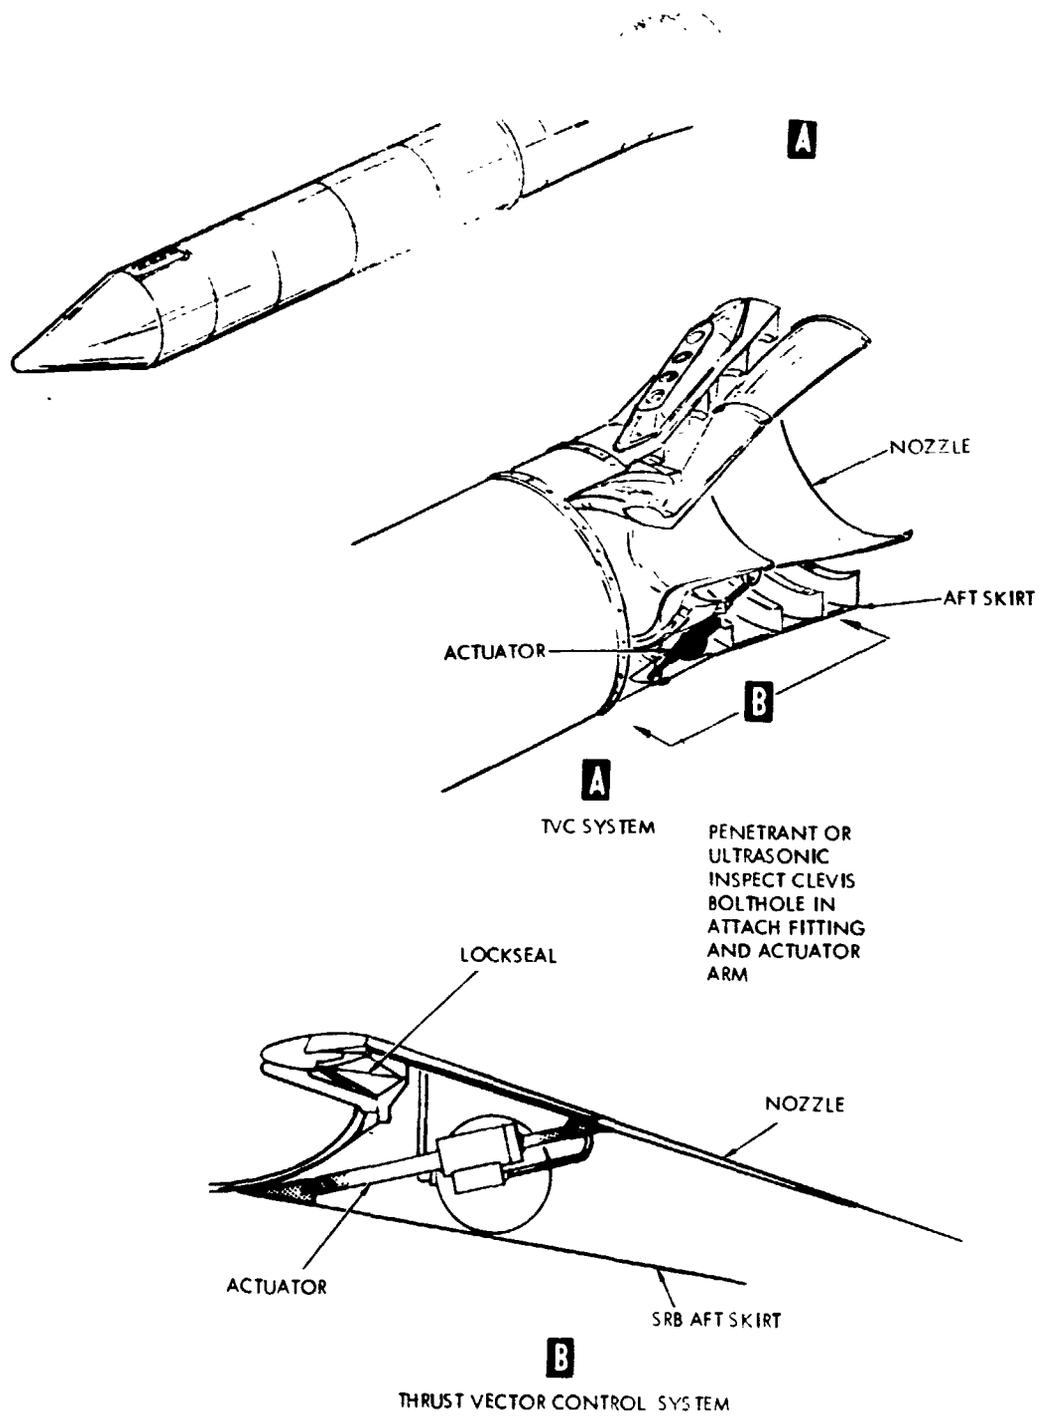
Figure 8-11. Thrust Vector Control Structure and Assembly

Optical alignment equipment should support assembly and provide capability for evaluation of actuation alignment criteria.

DETAILED EVALUATION OF NONCONFORMING CONDITIONS: Checkout tests should reveal leakage, pressure regulation irregularities, valve sticking and similar hydraulic system problems. If the checkout is unsuccessful, the test rig can be utilized in the applicable mode to trace down defects and isolate components for repair or replacement.

<u>PROCEDURE NO:</u>	8-915, FIGURE 8-11	<u>TYPE INSPECTION:</u>
<u>MAJOR ASSEMBLY:</u>	SRB, AFT STRUCTURE ZONE 9	(X) PREFLIGHT
<u>SUBASSEMBLY:</u>	THRUST VECTOR CONTROL (TVC) STRUCTURE AND ASSEMBLY	(X) POST RETRIEVAL (X) NON CONFORMANCE

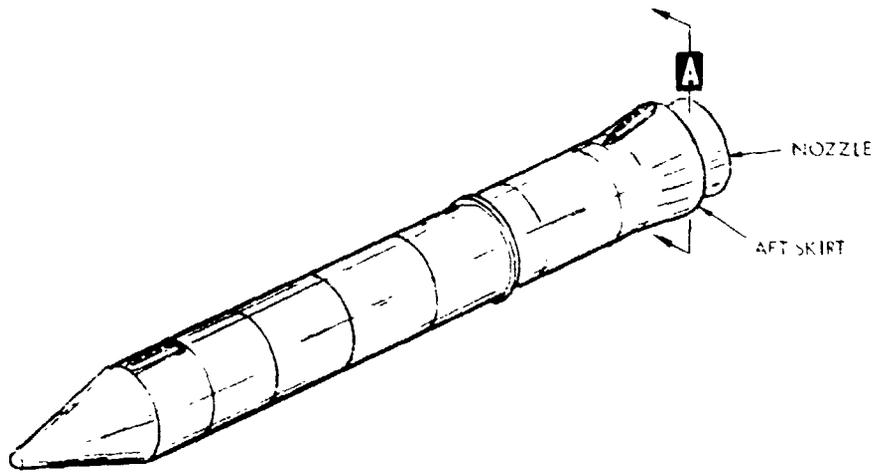
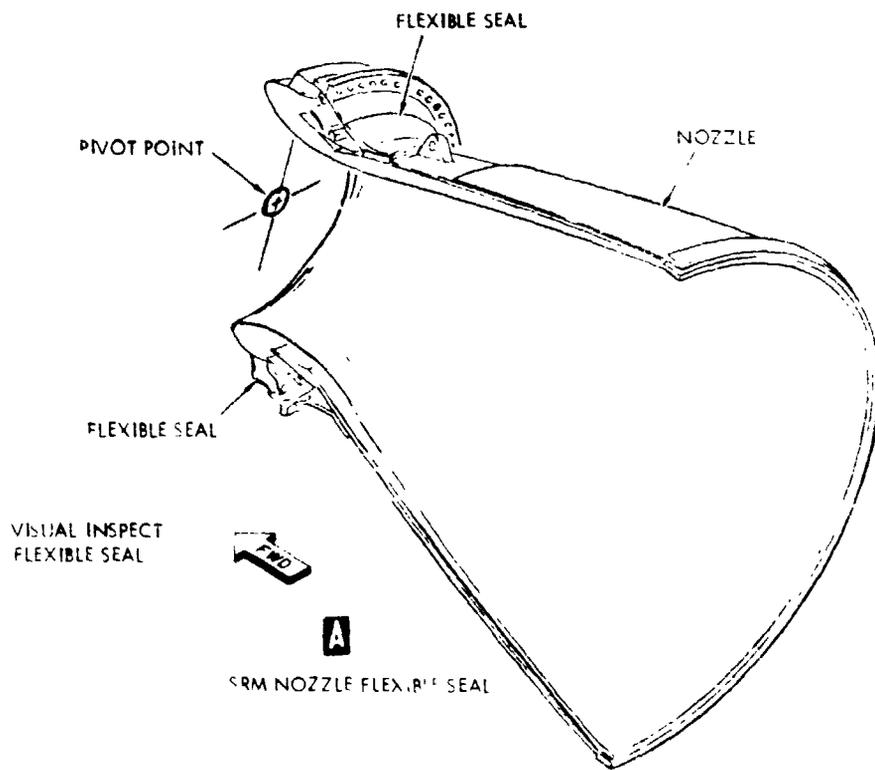
Figure 8-12. Nozzle Flexible Seal

ACCESS: The steel to elastomer bond line is accessible only at the edge.

NDT TECHNIQUES: The flexible seal should be visually inspected during prelaunch inspection. After assembly into the SRB the flexible seal should be run through the duty cycle that will characterize the mission except that the checkout should be limited to 4 degrees, half of the design vector angle.

PROCEDURE NO: 8-916, FIGURE 8-12

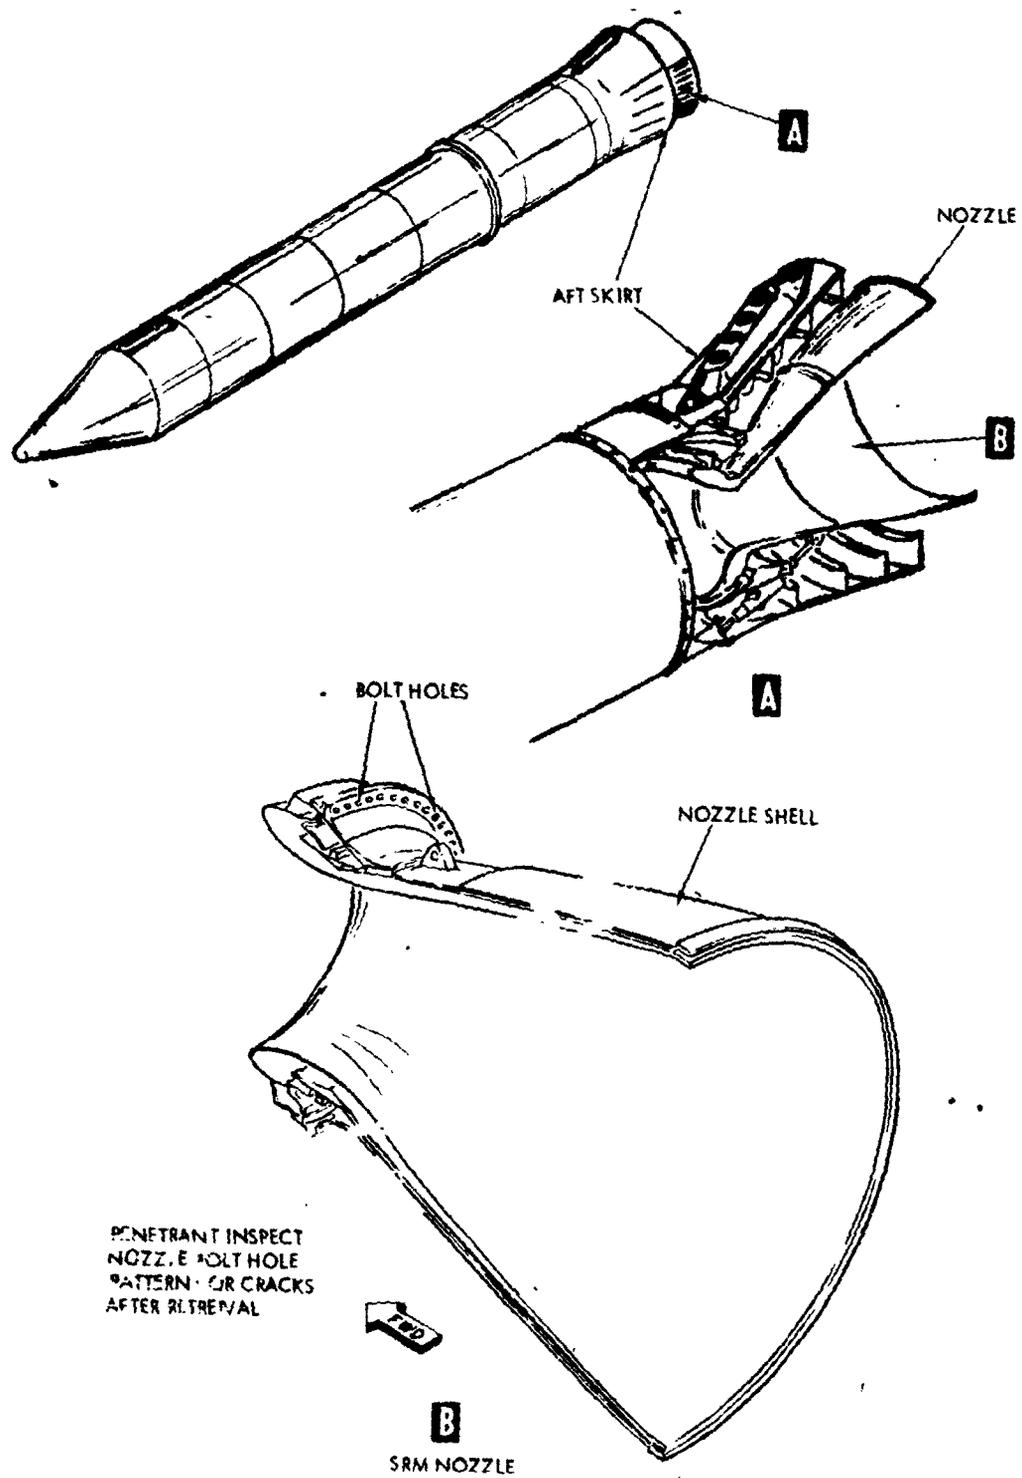
Figure 8-13. Nozzle Shell

Bolt Holes :

1. For non-conforming bolt holes, the inside diameter should be inspected using eddy current bolt hole (Para. 1.5.4.3) inspection.

PROCEDURE NO: 8-917, FIGURE 8-13
MAJOR ASSEMBLY: S^{DB}, MOVABLE NOZZLE
ZONE 9
SUBASSEMBLY: NOZZLE SHELL

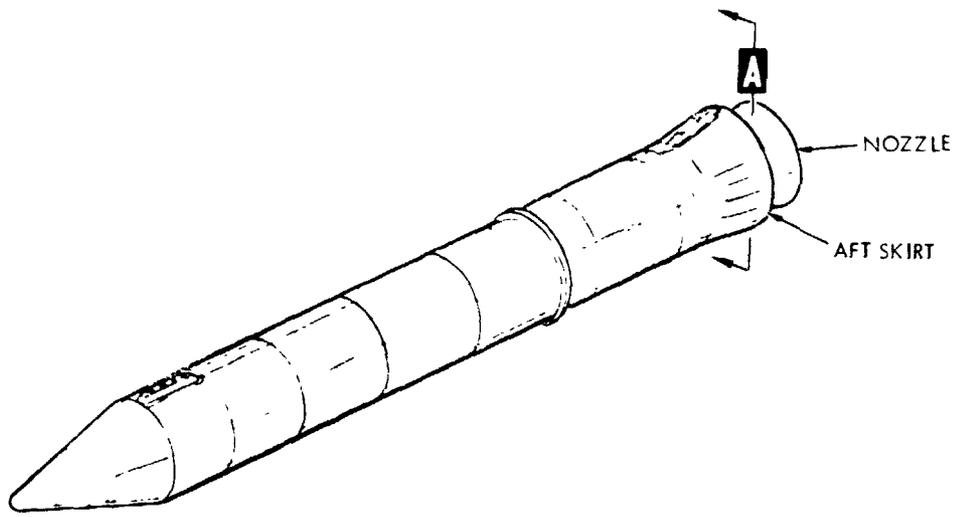
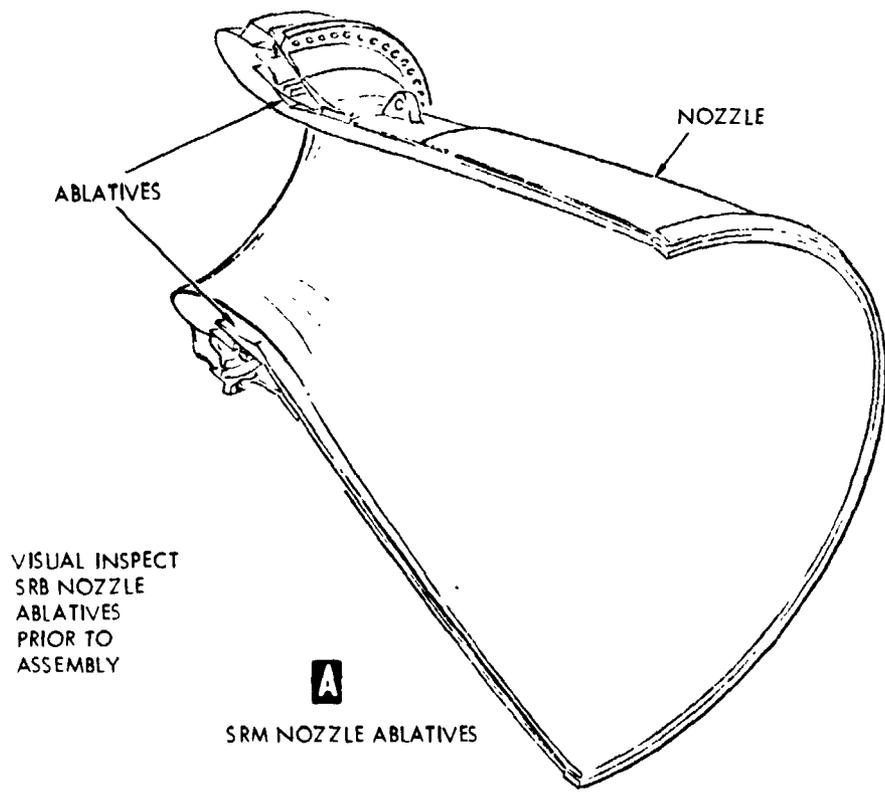
Figure 8-14. Nozzle Ablatives

ACCESS: The nozzle throat is accessible for inspection.

NDT TECHNIQUES: Thrust alignment of the motor to the orbiter will be made by optical measurements. If mechanical tooling is used to support optical targets or locate the centerline of the nozzle and if this tooling is mounted on the nozzle ablative parts, the tooling points of contact with the ablatives should be inspected by the alcohol penetrant method. Otherwise, only visual inspection of the ablatives is required.

PROCEDURE NO: 8-918, FIGURE 8-14

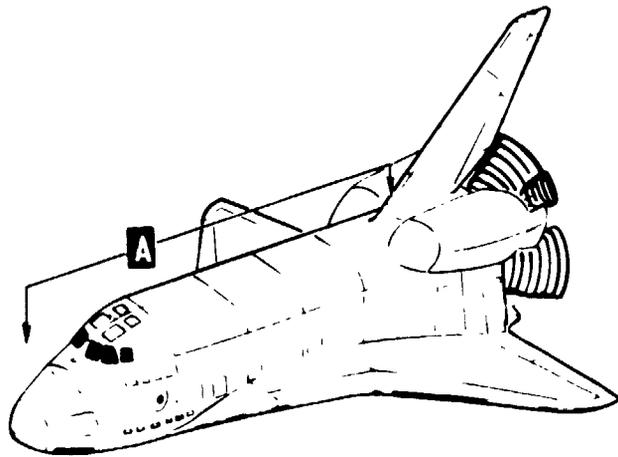
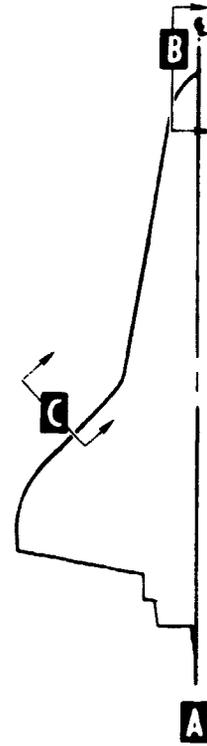
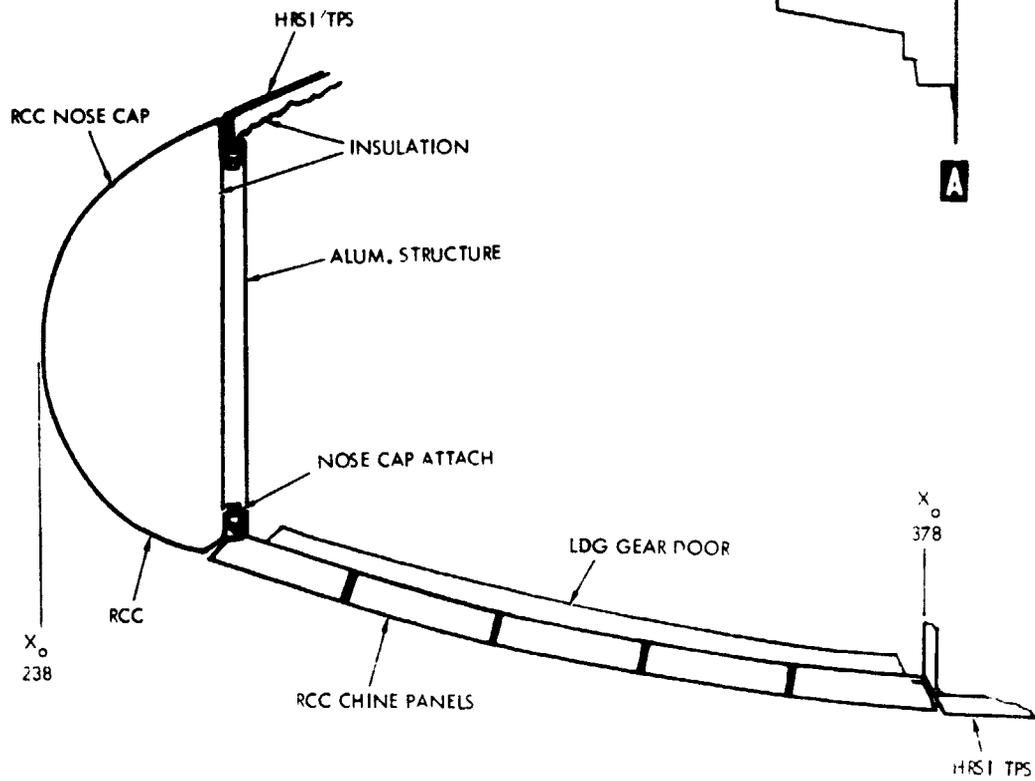
Figure 9-2. RCC Wing Leading Edge and Nose Cap (Sheet 1 of 2)

B RCC /TPS NOSE CAP AND CHINE PANELS

COMPONENT/AREA DESCRIPTION: REINFORCED CARBON/CARBON (RCC) LEADING WING EDGES AND FWD FUS NOSE CAP. The Orbiter wing leading edges, including the wing glove leading edges, and the forward fuselage nose cap consist of molded panels of carbon fiber reinforced carbon epoxy matrix which form rigid, high-temperature-resistant aerodynamic foils, as illustrated in Figure 9-1. The system is further coated with, or contains an intrinsic, oxidation inhibitor to prevent surface chemical degradation at high entry temperatures. This system is part of the Orbiter thermal protection system (TPS) designed to protect the metal leading edge structure from the highest temperature expected to be encountered during vehicle ascent and entry into the atmosphere from orbit - between 2300°F and 3000°F. The RCC leading edge panels are attached to the wing leading edge spar with titanium alloy trusses, brackets and fittings such as shown in Figure 9-2. They are reinforced by formed rib stiffeners inside the leading edge cavity. The RCC panels interface with HRSI/TPS panels which protect wing and fuselage surfaces in the range of 1200°F to 2300°F. The Orbiter entry isothermal lines are shown as degrees Fahrenheit in Figure 9-3.

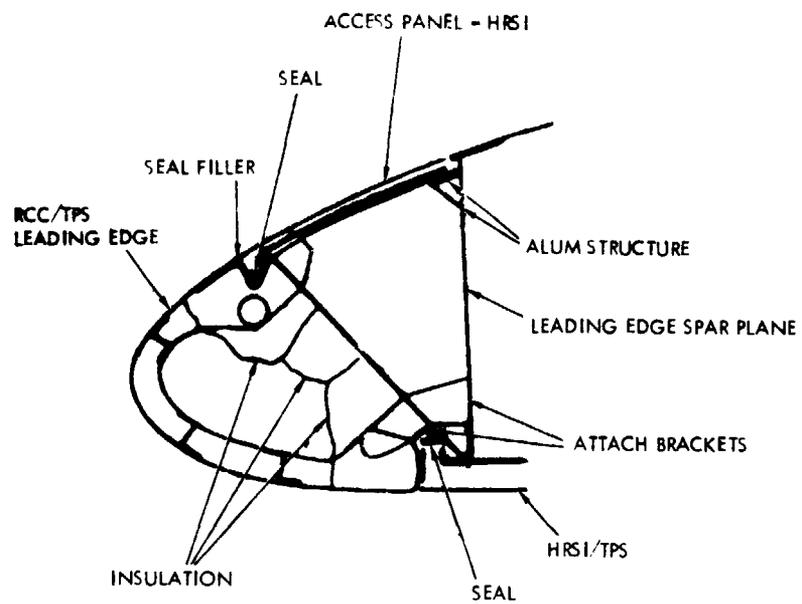
Figure 9-2. RCC Wing Leading Edge and Nose Cap (Sheet 2 of 2)

RCC/TPS WING LEADING EDGE

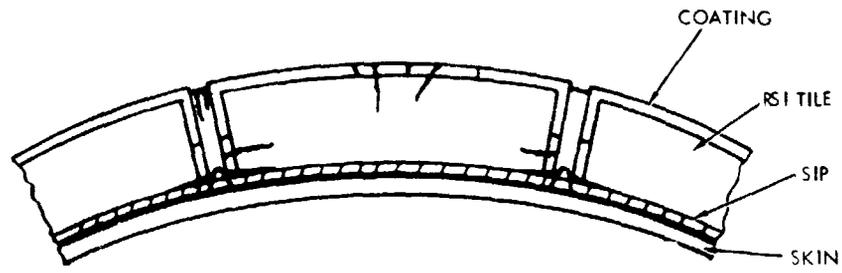
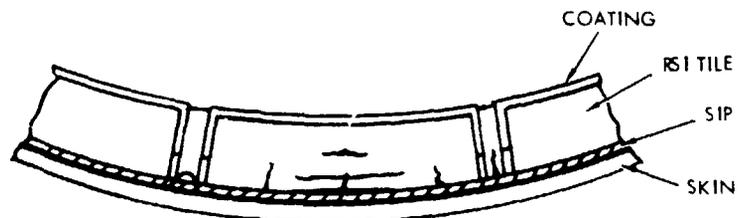
Figure 9-5. Shape, Size and Quantity of RSI/TPS Tiles for Five Orbiters
 (Sheet 2 of 2)

DOWN BENDING MODE:

COATING CRACKS
 VERTICAL SURFACE CRACKS
 EDGE DISBONDING
 HORIZONTAL SHEAR CRACKS

EXAGGERATED STRAINS

UP-BENDING MODE:

COATING SPALLING
 ADHESIVE DEBONDS AT CENTER
 PANEL DELAMINATIONS NEAR BONDLINE
 HORIZONTAL SHEAR CRACKS AT EDGE
 PANEL DELAMINATIONS NEAR MIDDLE
